# AUDENSHAW SCHOOL

## ACCESSIBILITY AUDIT ACTION PLAN FEBRUARY 2024

*VERSION 16 – UPDATED SEPTEMBER 2025*

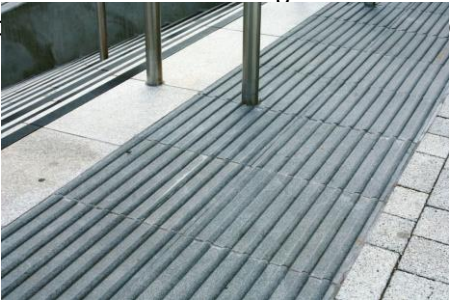
10.4	<p>Stairs do not have tactile warning surfaces to the top and bottom of the flight of stairs. This is a problem for people with impaired vision.</p>

<p>There should be a hazard warning of tactile surfacing on the top landing of the flight of stairs that should be positioned at least 400mm from the nosing. The highest priority are the steps which are 'open'.</p> <p>This should be implemented as part of an ongoing renovation plan for the site.</p>	OG	<b>Improvement Under Review – Priority 2</b>

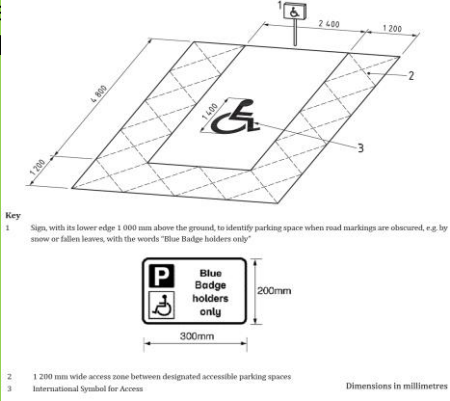
2.2B	The accessible parking bay does not have a sign to the front as recommended by the BS8300.	<p>Install a sign to the front of any accessible parking space.</p> <p>According to BS8300 - Sign should be present with its lower edge 1000 mm above the ground, to identify parking space, e.g. by snow or fallen leaves, e.g. by road holders</p>

<p>Key</p> <p>1. Sign, with its lower edge 1 000 mm above the ground, to identify parking space when road markings are obscured, e.g. by snow or fallen leaves, with the words "Blue Badge holders only"</p> <p>2. 1 200 mm wide access zone between designated accessible parking spaces</p> <p>3. International Symbol for Access</p> <p>Dimensions in millimetres</p>	M	Signs Installed April 2025
