# AUDENSHAW SCHOOL

## ACCESSIBILITY AUDIT ACTION PLAN FEBRUARY 2024

*VERSION 18 – UPDATED NOVEMBER 2025*

## Section 4 – Action Plan

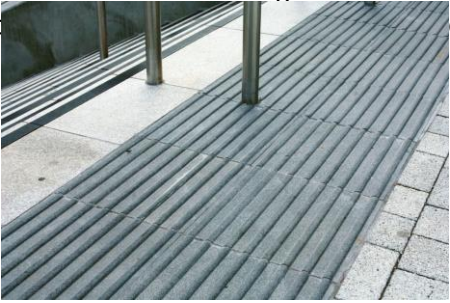
| 10.4 | <p>Stairs do not have tactile warning surfaces to the top and bottom of the flight of stairs. This is a problem for people with impaired vision.</p> | <p>There should be a hazard warning of tactile surfacing on the top landing of the flight of stairs that should be positioned at least 400mm from the nosing. The highest priority are the steps which are 'open'.</p> <p>This should be implemented as part of an ongoing renovation plan for the site.</p> | OG | Improvement Under Review – Priority 2 |

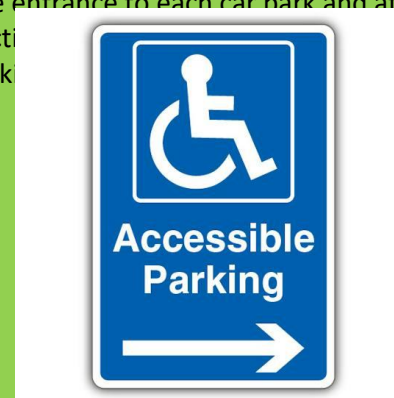
| 2.2A | There are no signs on entry to the car park to indicate where the accessible bay is located. | <p>There should be a sign at the entrance to the car park to indicate where the accessible parking spaces are located.</p> <p>Refer to BS8300, A sign or, if appropriate, signs should be provided at the entrance to each car park and at each change in direction of travel to each designated parking space.</p> | M | <b>Signs Installed<br/>April 2025</b> |

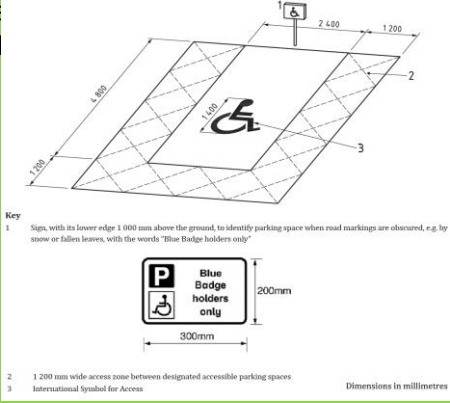
| 2.2B | The accessible parking bay does not have a sign to the front as recommended by the BS8300. | <p>Install a sign to the front of any accessible parking space.</p> <p>According to BS8300 - Sign should be present with its lower edge 1000 mm above the ground, to identify parking space, e.g. by snow or fallen leaves, e.g. by road holders</p> <p>Key</p> <p>1. Sign, with its lower edge 1 000 mm above the ground, to identify parking space when road markings are obscured, e.g. by snow or fallen leaves, with the words "Blue Badge holders only"</p> <p>2. 1 200 mm wide access zone between designated accessible parking spaces</p> <p>3. International Symbol for Access</p> <p>Dimensions in millimetres</p> | M | Signs Installed April 2025 |
