AUDENSHAW SCHOOL

ACCESSIBILITY AUDIT ACTION PLAN FEBRUARY 2024

VERSION 19 – UPDATED DECEMBER 2025

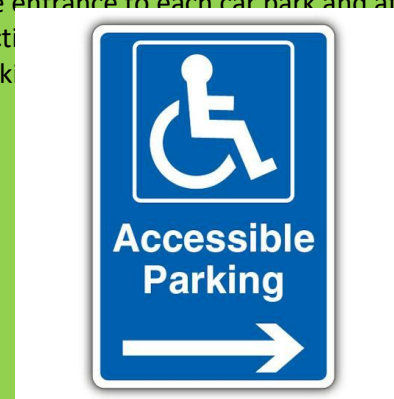
2.2A	There are no signs on entry to the car park to indicate where the accessible bay is located.	<p>There should be a sign at the entrance to the car park to indicate where the accessible parking spaces are located.</p> <p>Refer to BS8300, A sign or, if appropriate, signs should be provided at the entrance to each car park and at each change in direction of travel to each designated parking space.</p>	M	<p>Signs Installed April 2025</p>
------	--	---	---	--
