AUDENSHAW SCHOOL

ACCESSIBILITY AUDIT ACTION PLAN FEBRUARY 2024

VERSION 21 – UPDATED FEBRUARY 2026

Section 4 – Action Plan

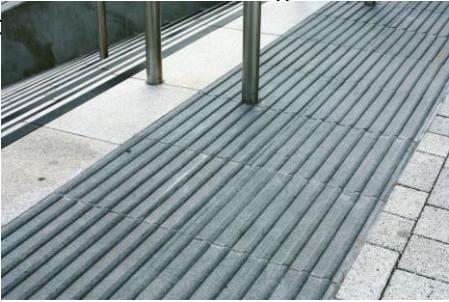
10.4	<p>Stairs do not have tactile warning surfaces to the top and bottom of the steps. This is a hazard for people with impaired vision.</p>

<p>There should be a hazard warning of tactile surfacing on the top landing of the flight of stairs that should be positioned at least 400mm from the nosing. The highest priority are the steps which are 'open'.</p> <p>This should be implemented as part of an ongoing renovation plan for the site.</p>	OG	Improvement Under Review – Priority 2

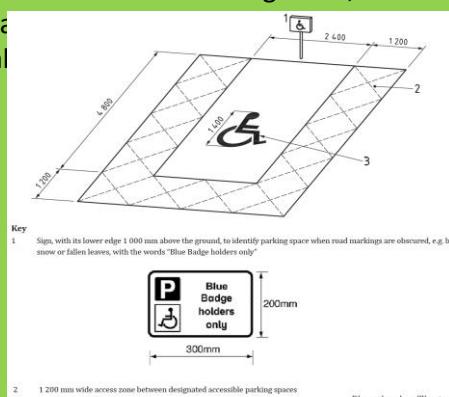
2.2B	<p>The accessible parking bay does not have a sign to the front as recommended by the BS8300.</p>	<p>Install a sign to the front of any accessible parking space.</p> <p>According to BS8300 - Sign should be present with its lower edge 1000 mm above the ground, to identify parking space, e.g. by snow or fallen leaves, with the words "Blue Badge holders only".</p>

<p>Key</p> <p>1 Sign, with its lower edge 1 000 mm above the ground, to identify parking space when road markings are obscured, e.g. by snow or fallen leaves, with the words "Blue Badge holders only".</p> <p>2 1 200 mm wide access zone between designated accessible parking spaces</p> <p>3 International Symbol for Access</p> <p>Dimensions in millimetres</p>	M	<p>Signs Installed April 2025</p>
