# AUDENSHAW SCHOOL

## ACCESSIBILITY AUDIT ACTION PLAN

FEBRUARY 2024

*VERSION 22 – UPDATED MARCH 2026*

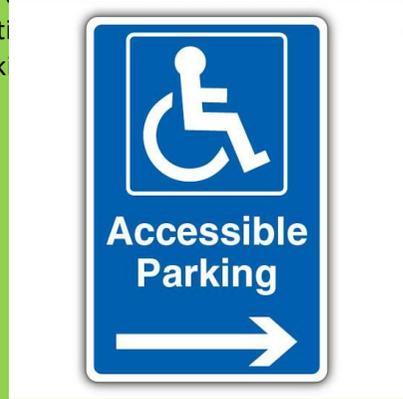
2.2A	There are no signs on entry to the car park to indicate where the accessible bay is located.	<p>There should be a sign at the entrance to the car park to indicate where the accessible parking spaces are located.</p> <p>Refer to BS8300, A sign or, if appropriate, signs should be provided at the entrance to each car park and at each change in direction of travel to each designated parking space.</p>	M	<b>Signs Installed April 2025</b>
------	--	---	---	---------------------------------------

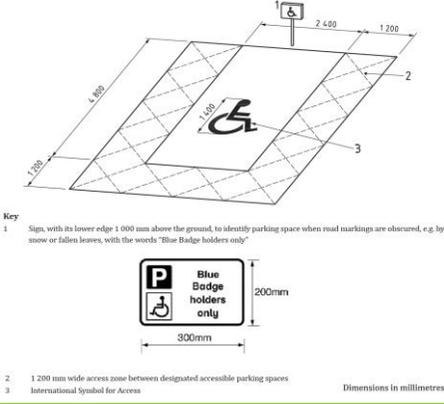
2.2B	The accessible parking bay does not have a sign to the front as recommended by the BS8300.	<p>Install a sign to the front of any accessible parking space.</p> <p>According to BS8300 - Sign should be present with its lower edge 1000 mm above the ground, to identify parking spaces, e.g. by snow or fallen leaves, with the words "Blue Badge holders only".</p>

<p>Key</p> <p>1 Sign, with its lower edge 1000 mm above the ground, to identify parking space when road markings are obscured, e.g. by snow or fallen leaves, with the words "Blue Badge holders only"</p> <p>2 1200 mm wide access zone between designated accessible parking spaces</p> <p>3 International Symbol for Access</p> <p>Dimensions in millimetres</p>	M	Signs Installed April 2025
