# Audenshaw School

## Accessibility Audit Action Plan

**February 2024**

*Version 25 - Updated June 2026*

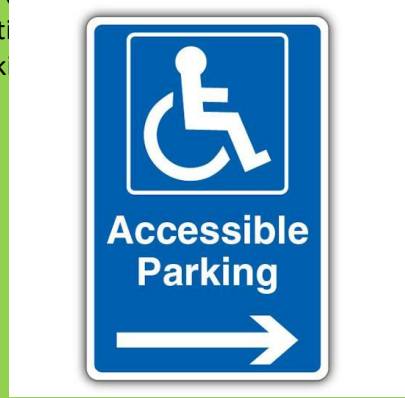
2.2A	There are no signs on entry to the car park to indicate where the accessible bay is located.	<p>There should be a sign at the entrance to the car park to indicate where the accessible parking spaces are located.</p> <p>Refer to BS8300, A sign or, if appropriate, signs should be provided at the entrance to each car park and at each change in direction to each designated parking space.</p>	M	<b>Signs Installed April 2025</b>
------	--	---	---	---------------------------------------

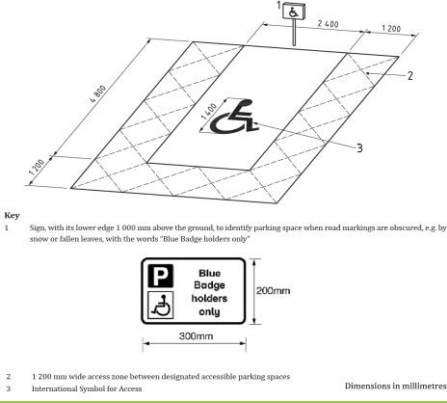
2.2B	The accessible parking bay does not have a sign to the front as recommended by the BS8300.	<p>Install a sign to the front of any accessible parking space.</p> <p>According to BS8300 - Sign should be present with its lower edge 1000 mm above the ground, to identify parking spaces, e.g. by snow or fallen leaves, with the words "Blue Badge holders only".</p>

<p>Key</p> <p>1 Sign, with its lower edge 1 000 mm above the ground, to identify parking space when road markings are obscured, e.g. by snow or fallen leaves, with the words "Blue Badge holders only"</p> <p>2 1 200 mm wide access zone between designated accessible parking spaces</p> <p>3 International Symbol for Access</p> <p>Dimensions in millimetres</p>	M	Signs Installed April 2025
