# AUDENSHAW SCHOOL

## ACCESSIBILITY AUDIT ACTION PLAN FEBRUARY 2024

*VERSION 28 – UPDATED SEPTEMBER 2026*

## Section 4 – Action Plan

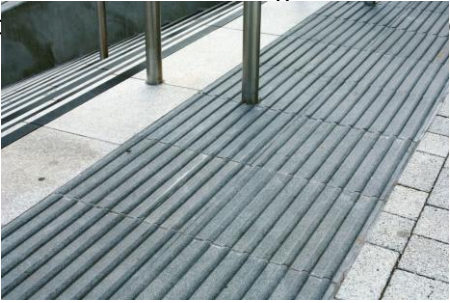
| 10.4 | <p>Stairs do not have tactile warning surfaces to the top and bottom of the flight of stairs. This is a problem for people with impaired vision.</p> | <p>There should be a hazard warning of tactile surfacing on the top landing of the flight of stairs that should be positioned at least 400mm from the nosing. The highest priority are the steps which are 'open'.</p> <p>This should be implemented as part of an ongoing renovation plan for the site.</p> | OG | <p><b>Improvement Under Review – Priority 2</b></p> |

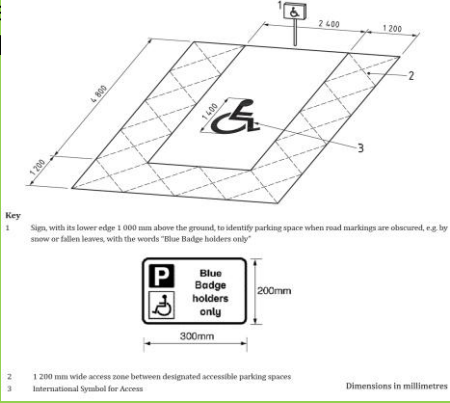
| 2.2B | The accessible parking bay does not have a sign to the front as recommended by the BS8300. | <p>Install a sign to the front of any accessible parking space.</p> <p>According to BS8300 - Sign should be present with its lower edge 1000 mm above the ground, to identify parking space, e.g. by snow or fallen leaves, e.g. by holders</p> <p>Key</p> <p>1. Sign, with its lower edge 1 000 mm above the ground, to identify parking space when road markings are obscured, e.g. by snow or fallen leaves, with the words "Blue Badge holders only"</p> <p>2. 1 200 mm wide access zone between designated accessible parking spaces</p> <p>3. International Symbol for Access</p> <p>Dimensions in millimetres</p> | M | Signs Installed April 2025 |
