# AUDENSHAW SCHOOL

## ACCESSIBILITY AUDIT ACTION PLAN FEBRUARY 2024

*VERSION 29 – UPDATED OCTOBER 2026*

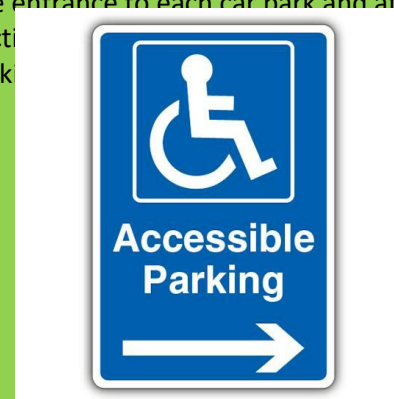
| 2.2A | There are no signs on entry to the car park to indicate where the accessible bay is located. | <p>There should be a sign at the entrance to the car park to indicate where the accessible parking spaces are located.</p> <p>Refer to BS8300, A sign or, if appropriate, signs should be provided at the entrance to each car park and at each change in direction of travel to each designated parking space.</p> | M | <b>Signs Installed<br/>April 2025</b> |
